## 8 SUMMARY OF POTENTIAL DS2 FAILURE MODES

## 8.1 DS2 Failure Mode Assessments

## 9 DS2 DISCIPLINE AREA ASSESSMENTS

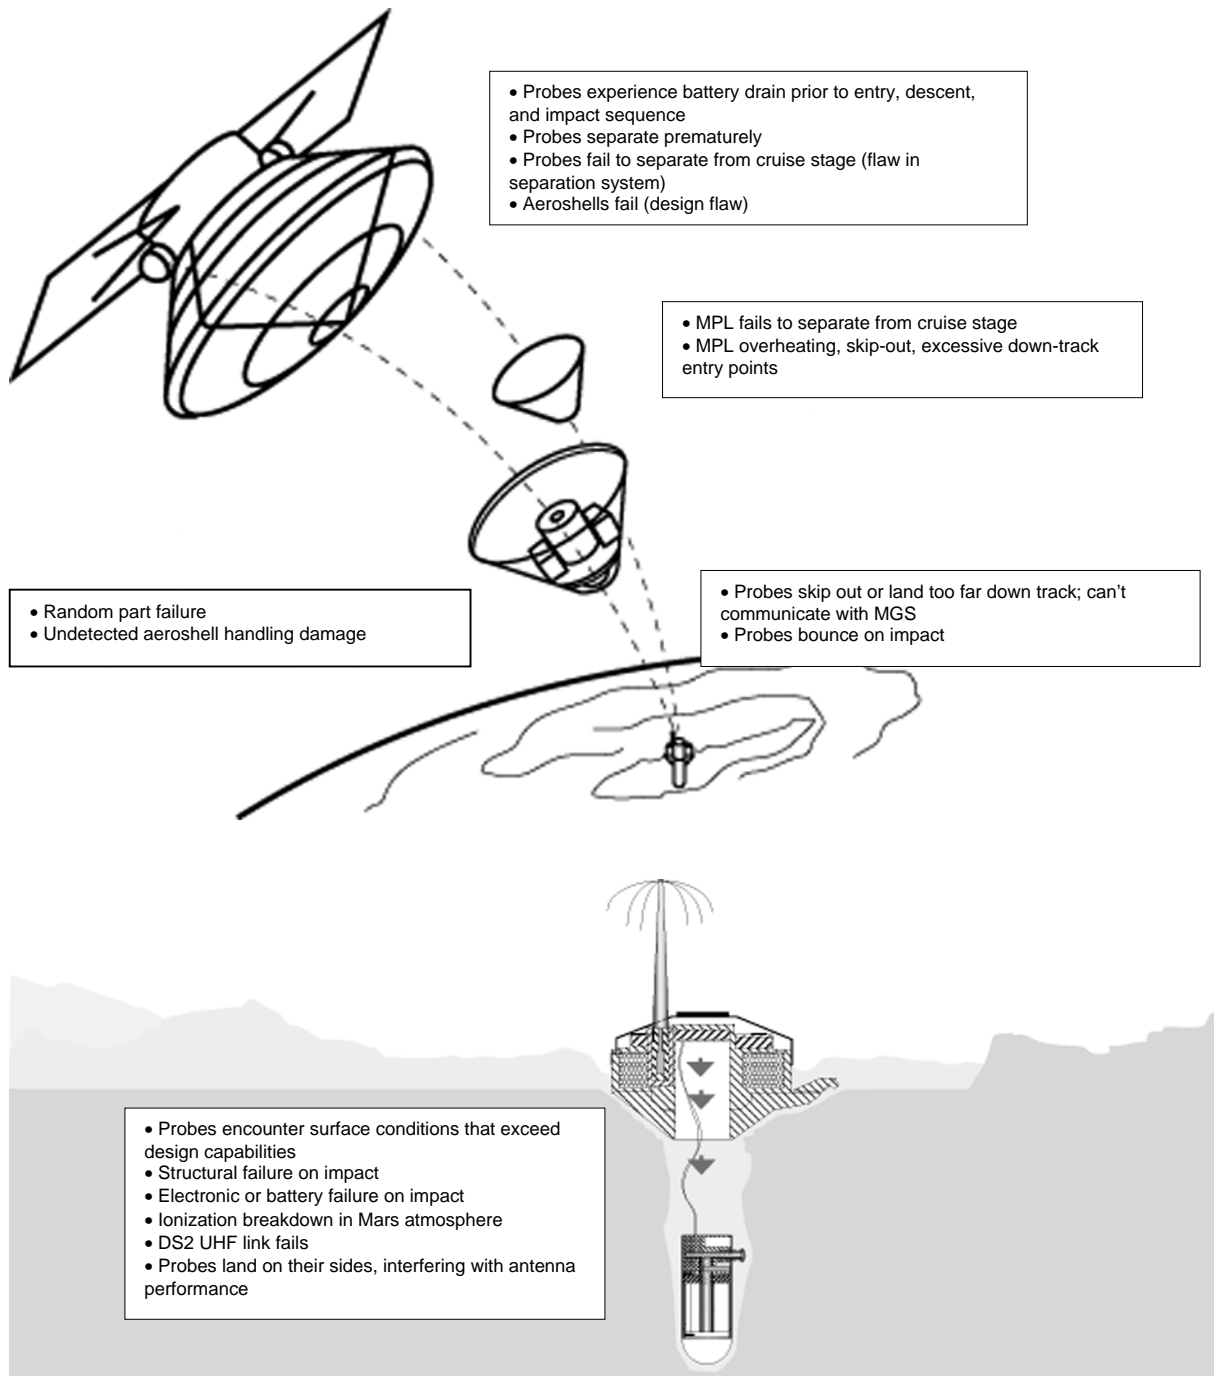
**Figure 8-1. DS2 Entry, Descent, and Impact Sequence with Potential Failure Modes**

Figure 8-1 illustrates the DS2 entry, descent, and impact (EDI) sequence and shows potential failure modes.
